From: Rao, Kate
Sent: Tuesday, August 11, 2015 10:37 AM
Subject: Gold King Mine Spill - brief background and initial EPA Region 9 response (internal - do not release)

Below is some background information and initial steps that EPA Region 9 is taking to respond to the Gold King Mine spill. Approximately 3 million gallons of mine wastewater/drainage/sludge was released from a dormant mine (Gold King) and flowed into Cement Creek which is a tributary of Animas River. The Animas River connects with the San Juan River which is a source of drinking water for the Navajo Nation. The plume reached the Navajo Nation on Saturday (August 8th).

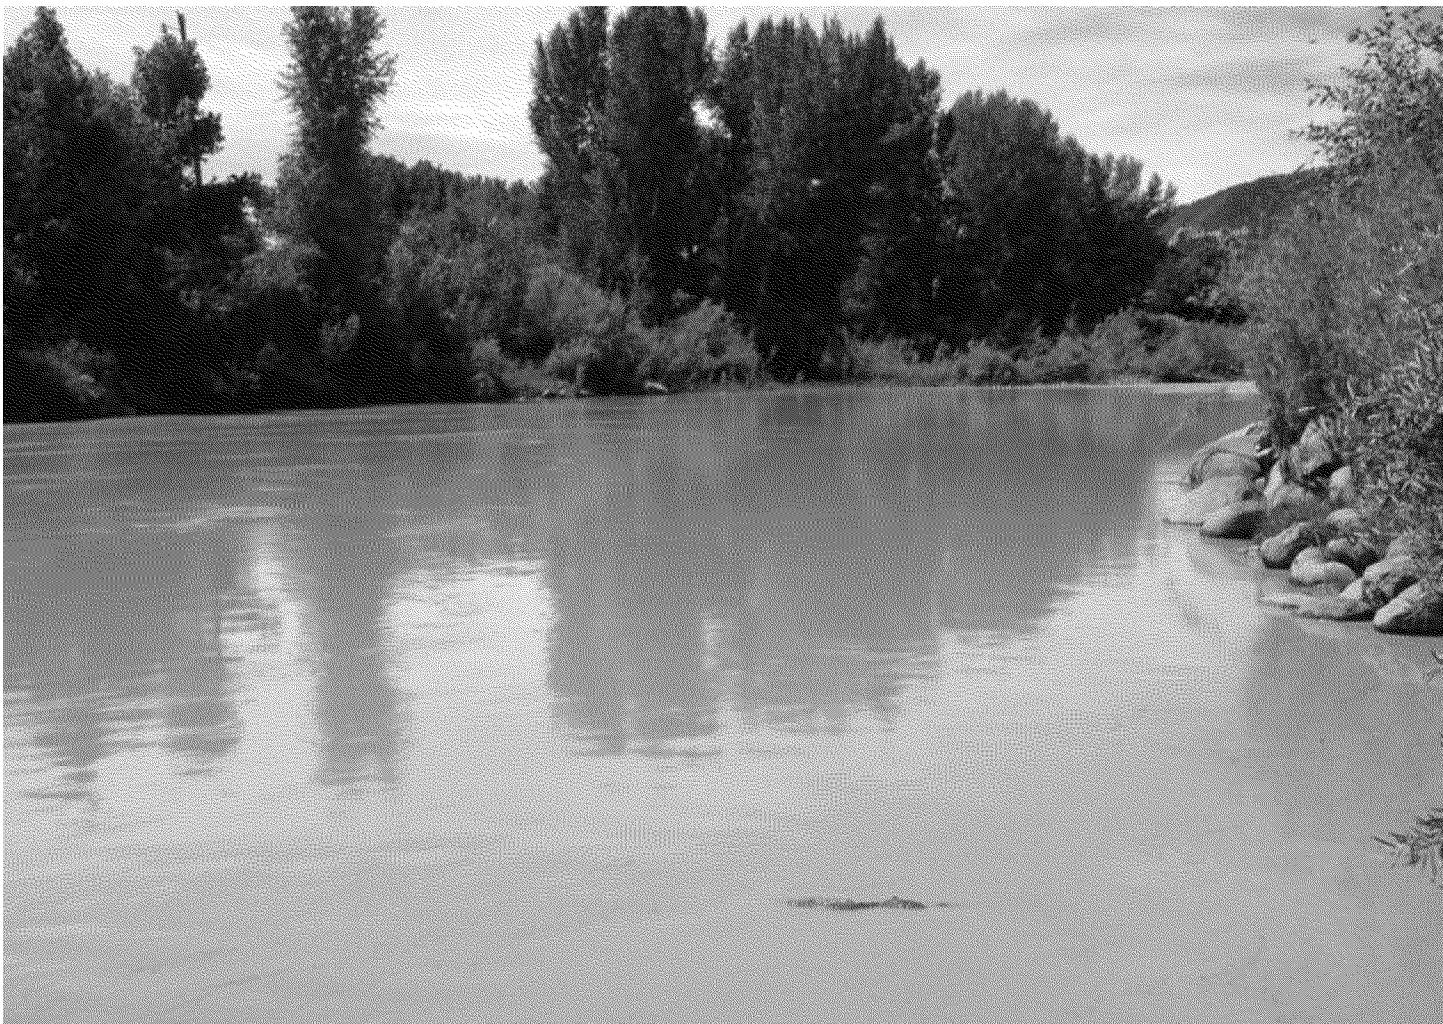
The river turned a mustardy-Tang color as the wastewater moved through. This was taken about 24 hours after the spill.

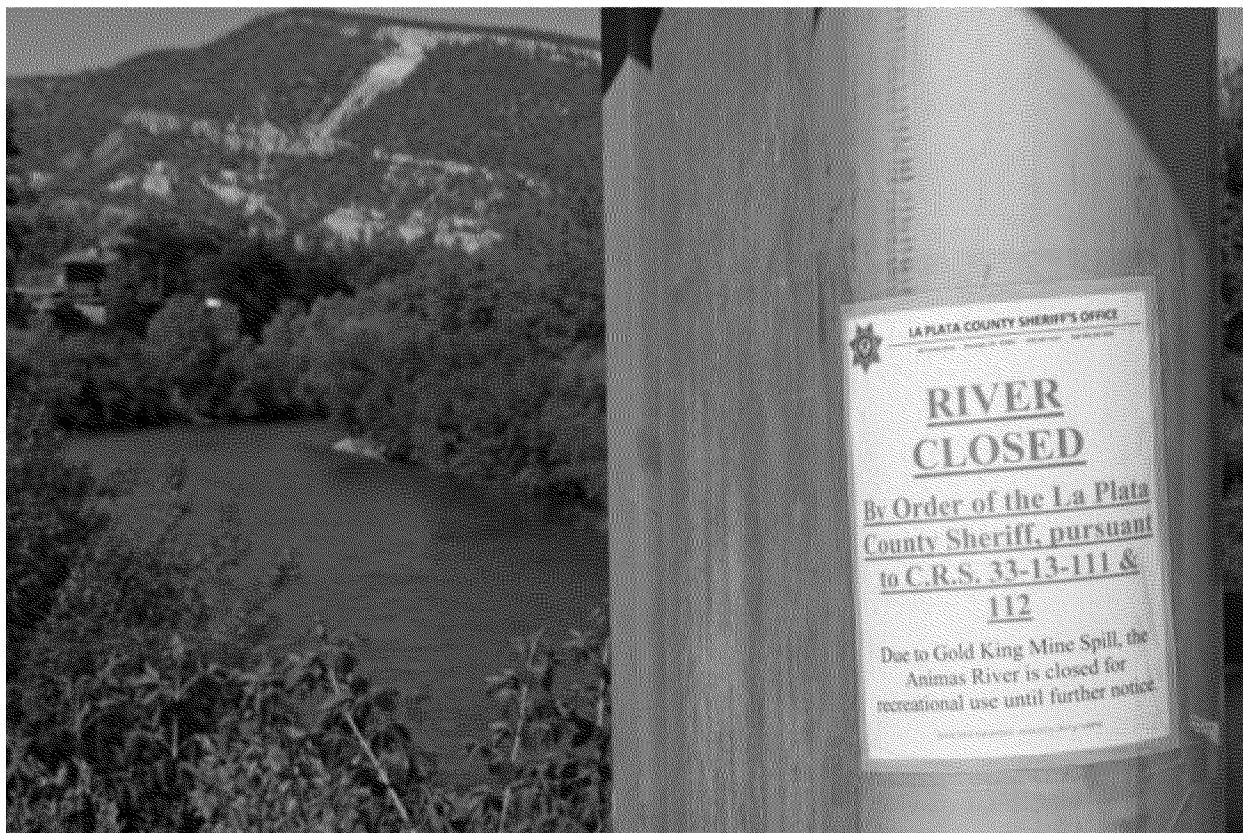
The Animas River was closed for public safety as the wastewater plume moved through town.

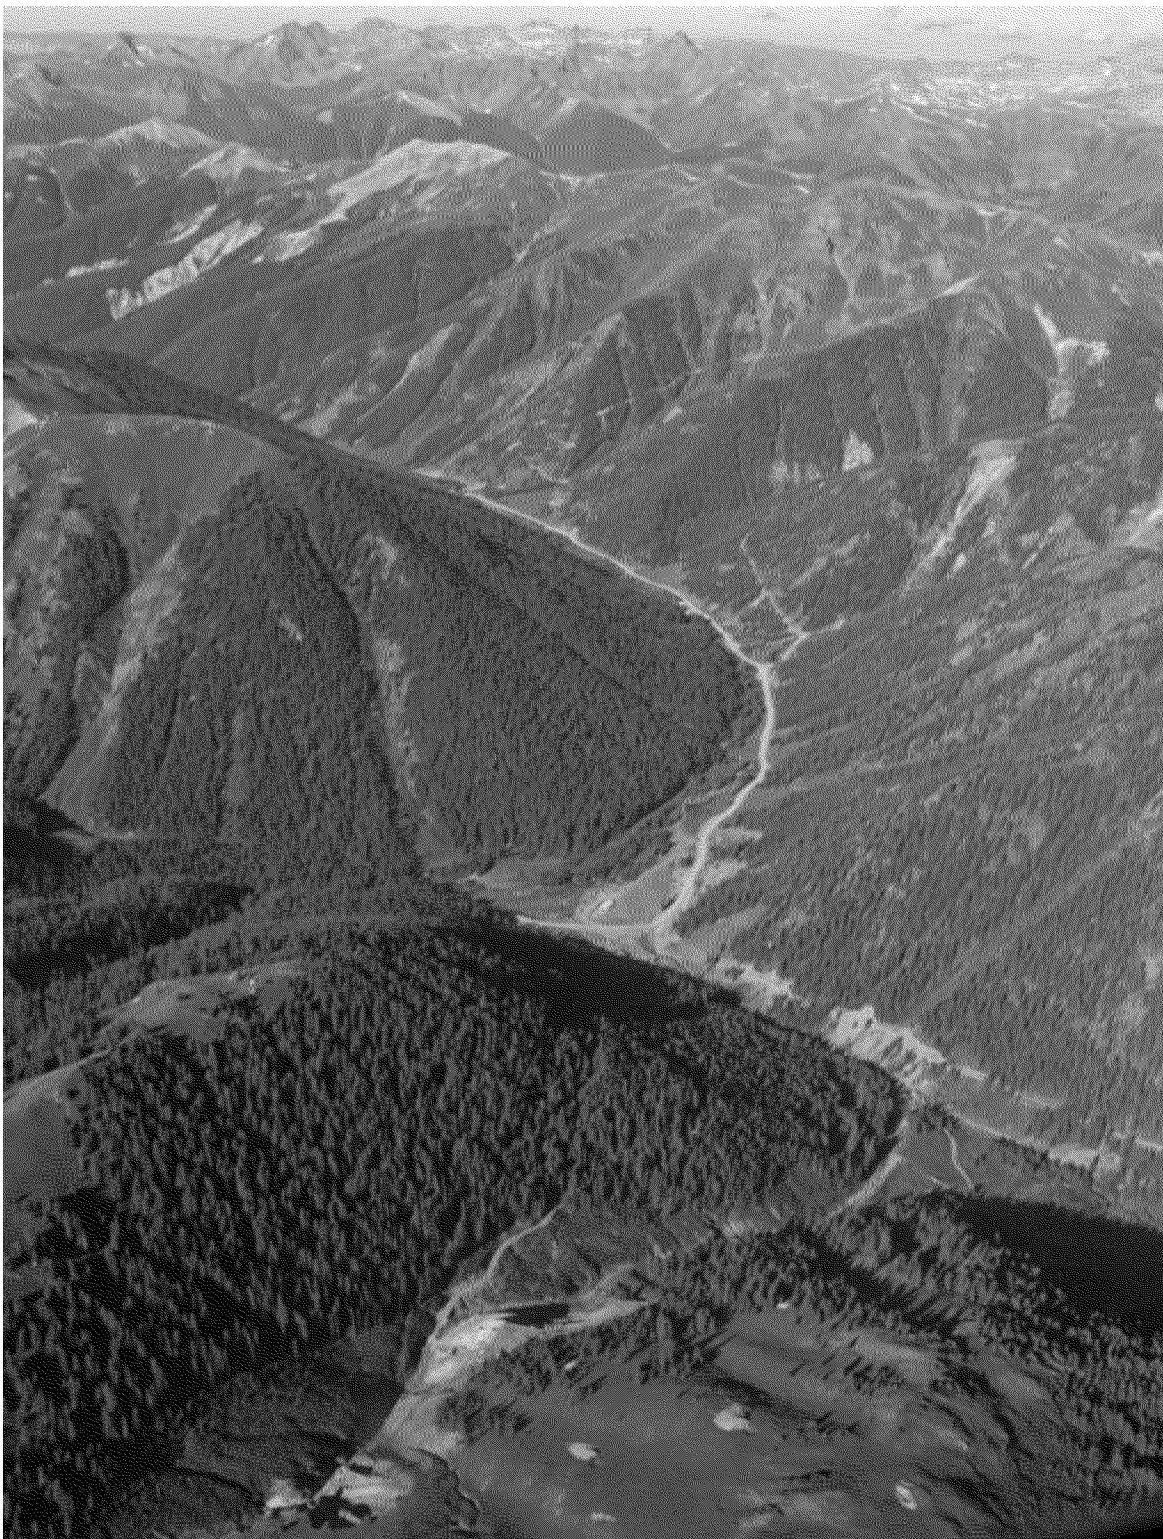
The Gold King Mine (bottom of picture) and Cement Creek. Cement Creek has probably never supported fish, and even before the spill had a pH level of about 3.5, on par with Coca-Cola.

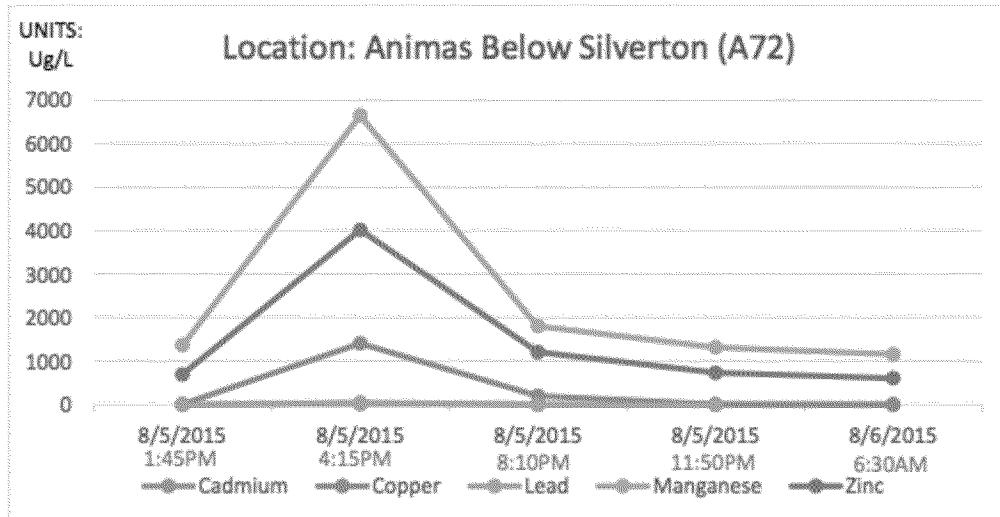
Samples taken by the EPA as the plume moved through show that it has high levels of heavy metals.

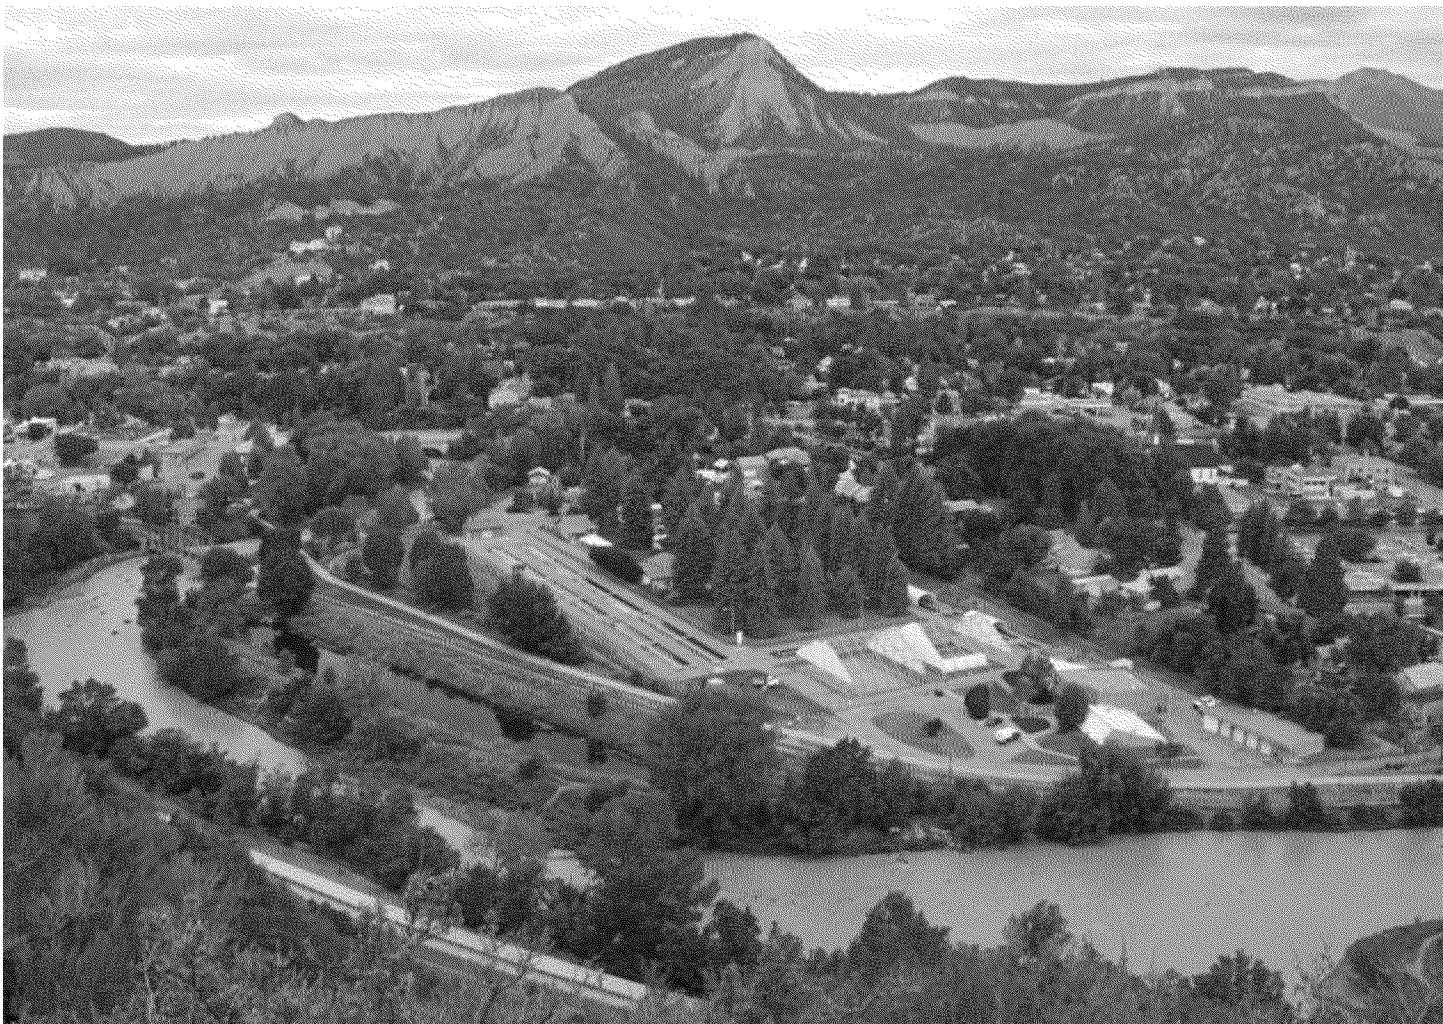
The contaminated Animas River as it runs through Durango. Note the contrast between the river and a fish hatchery pond next to it.
